THE FAILURE OF NIMROD MAIN MAGNET POWER  
SUPPLY ALTERNATORS

H. C. BROOKS  
(Rutherford High Energy Laboratory, England)

A. B. D. REED  
(English Electric Co. Ltd., England)

SYNOPSIS

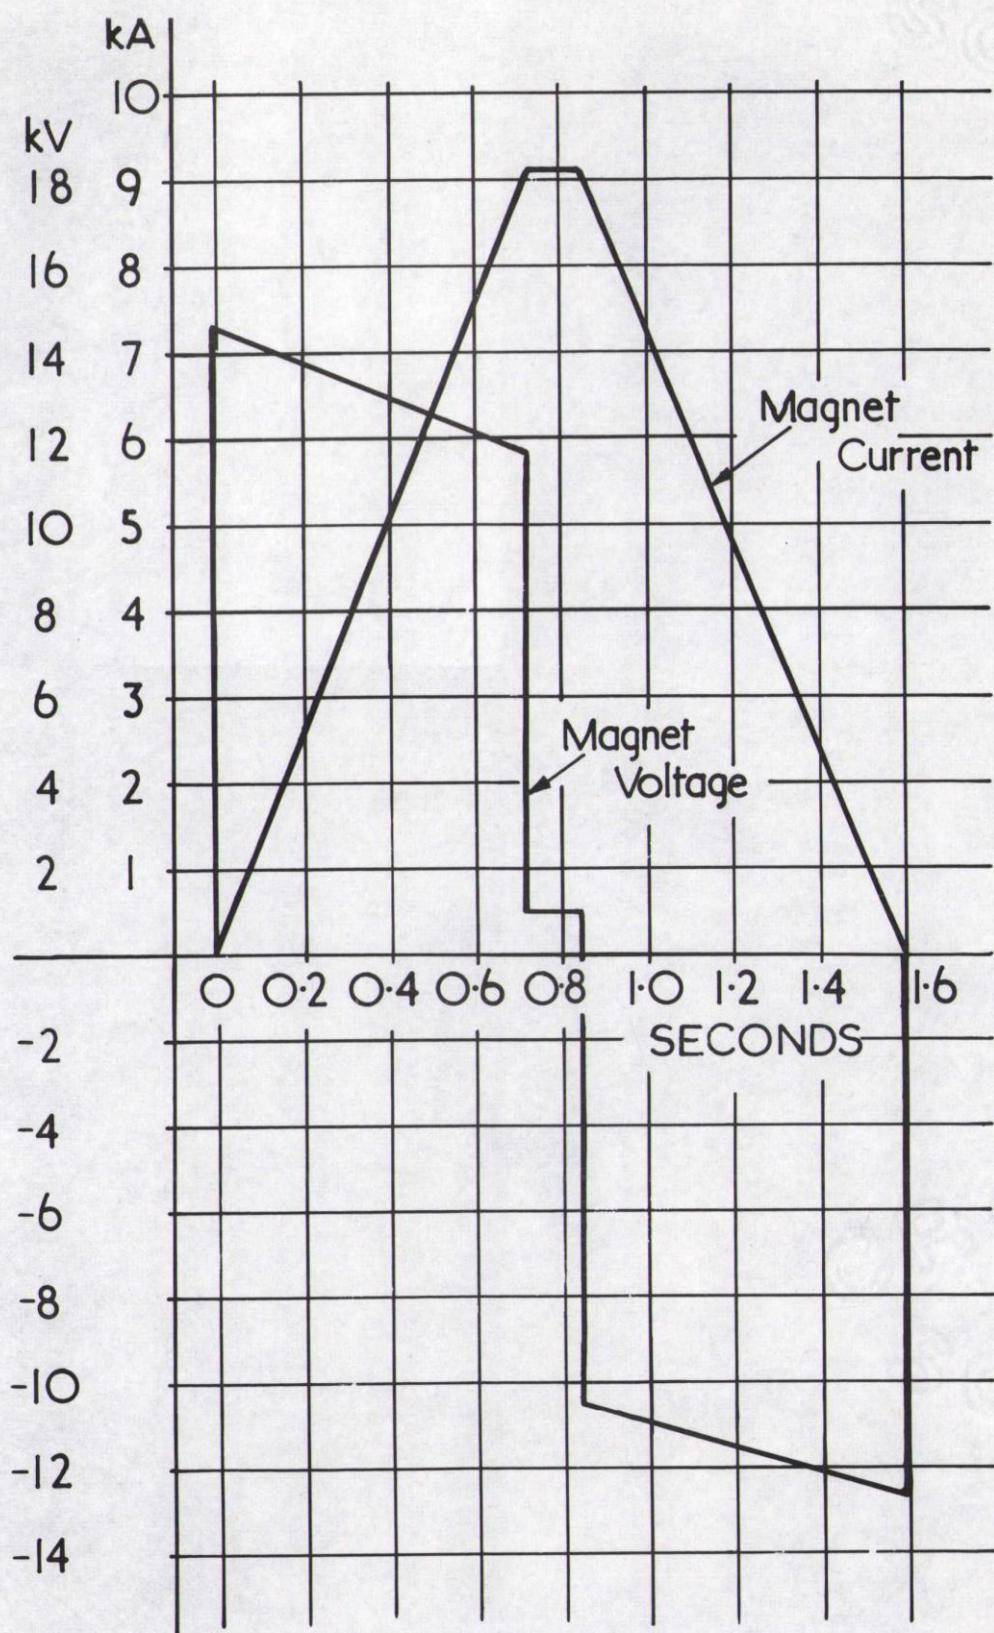
FIG.1 SIMPLIFIED PULSE WAVEFORMS OF MAGNET CURRENT & VOLTAGE

The synchrotron magnet has to be pulsed and at the commencement of each pulse 15 KV DC is applied to cause the current to rise from zero to 9,150 amps in 0.72 seconds. The energy stored in the magnetic field at this current is about 40 MJ. A typical magnet pulse is shown in Fig.1.

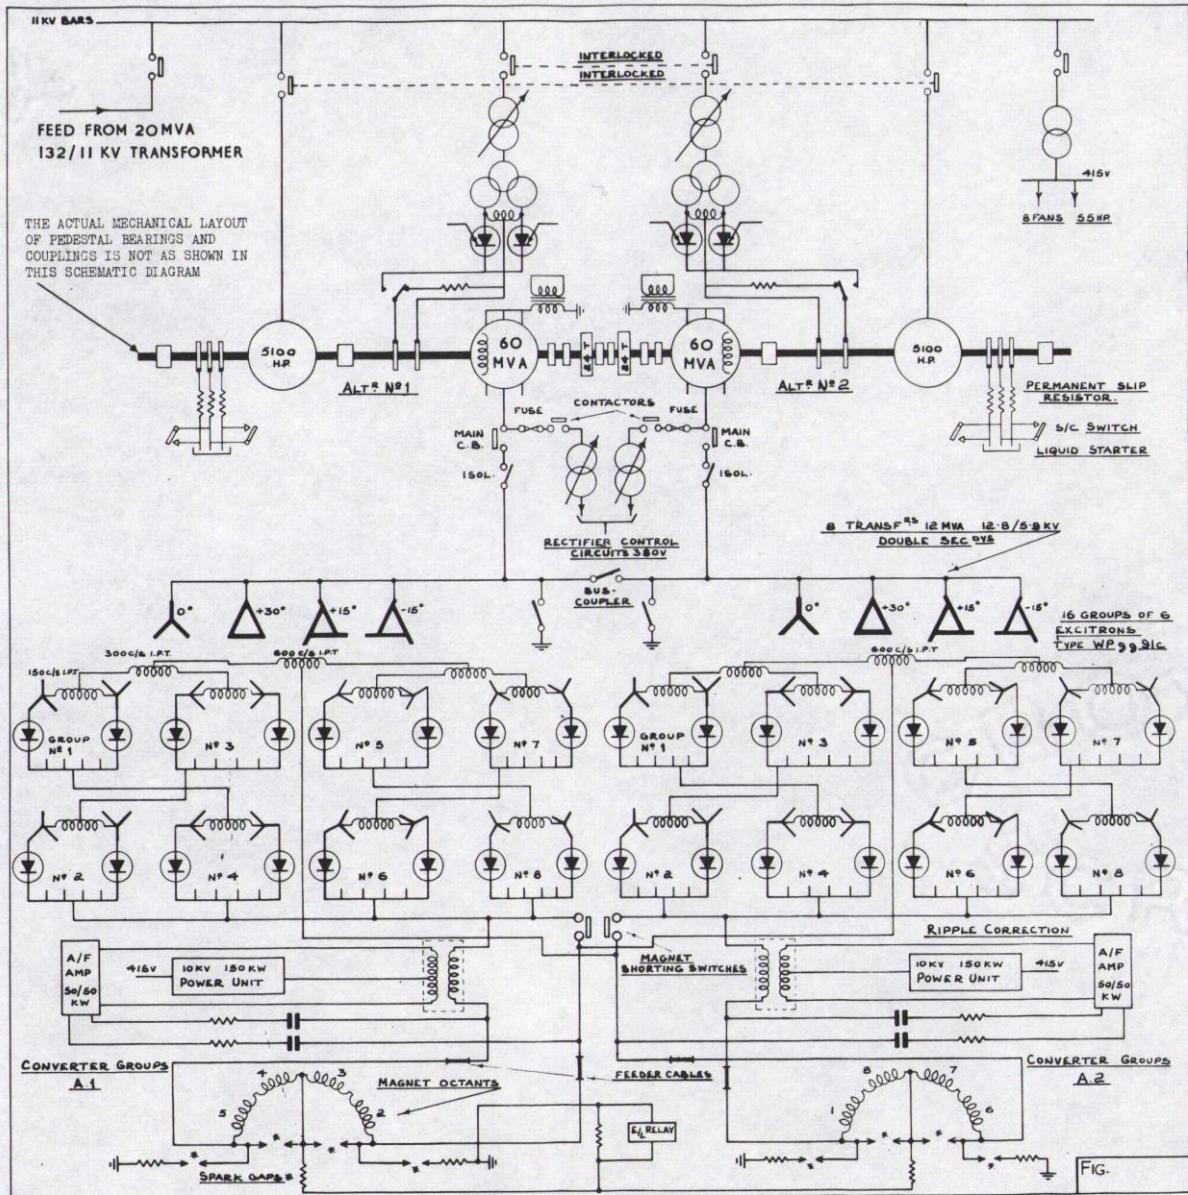
Fig. 2 Nimrod Power Plant Schematic Diagram.

Fig.2 shows the circuit diagram of the power supply installation.

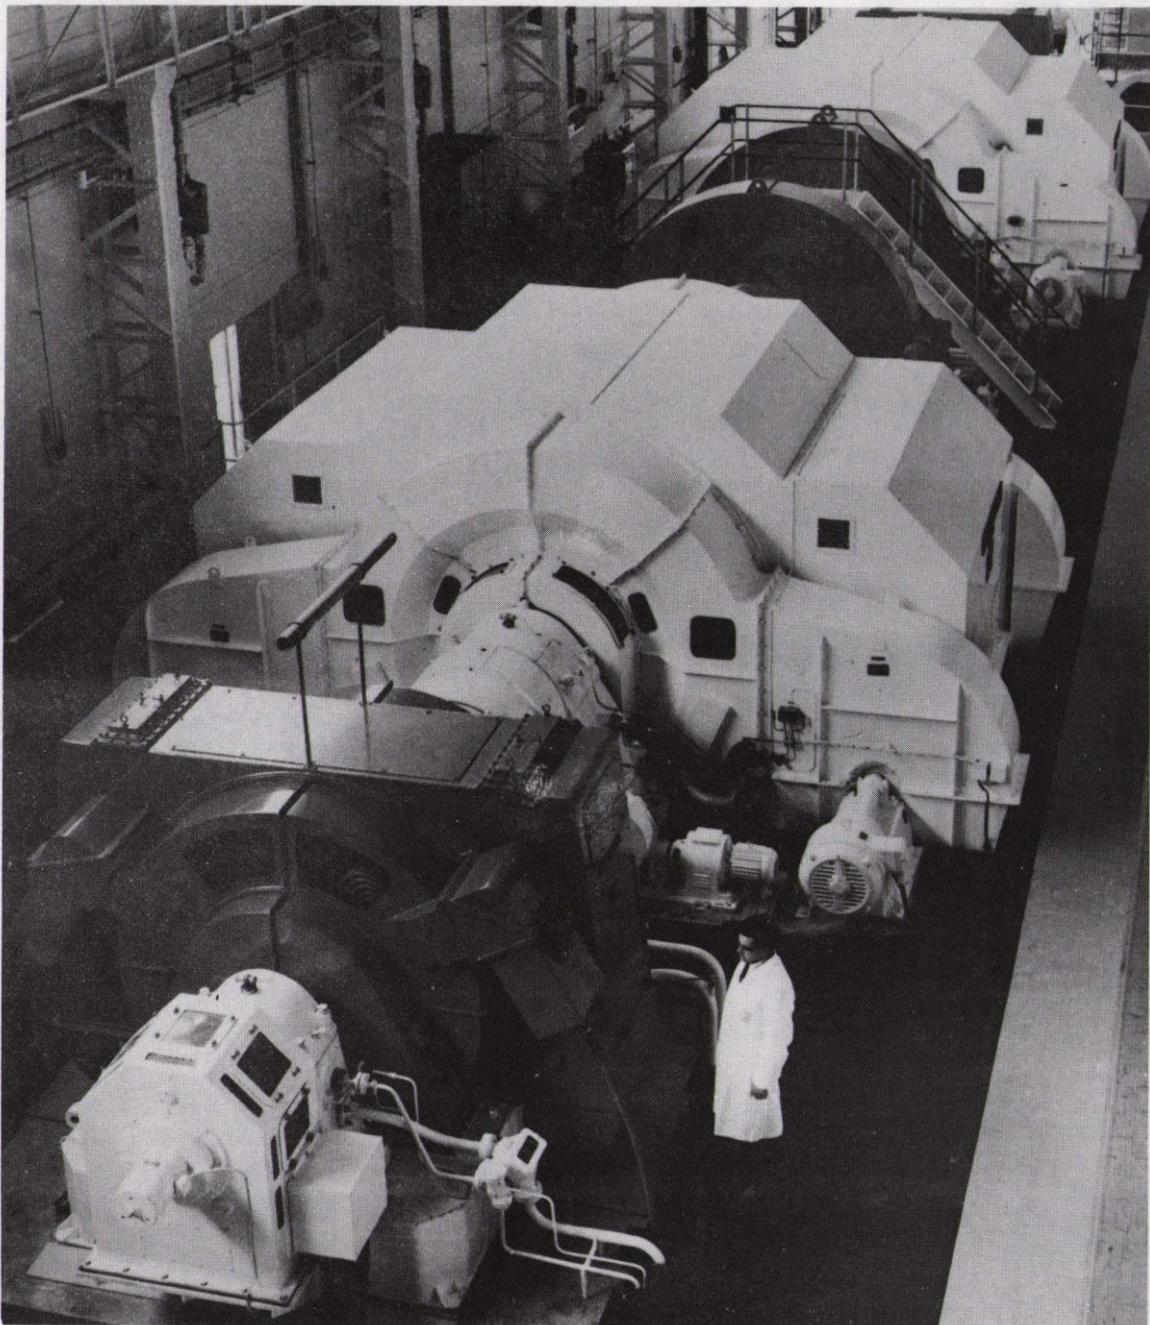
**FIG.3 MOTOR-ALTERNATOR-FLYWHEEL SETS**

Fig.3 is an illustration of the rotating plant.

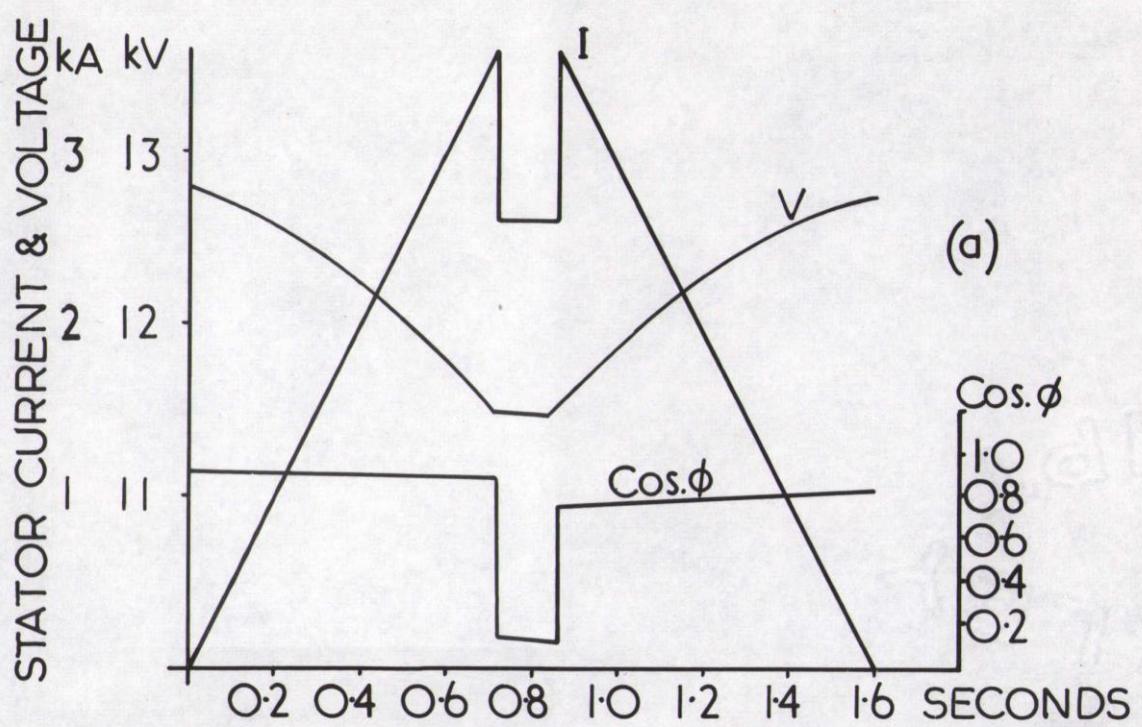
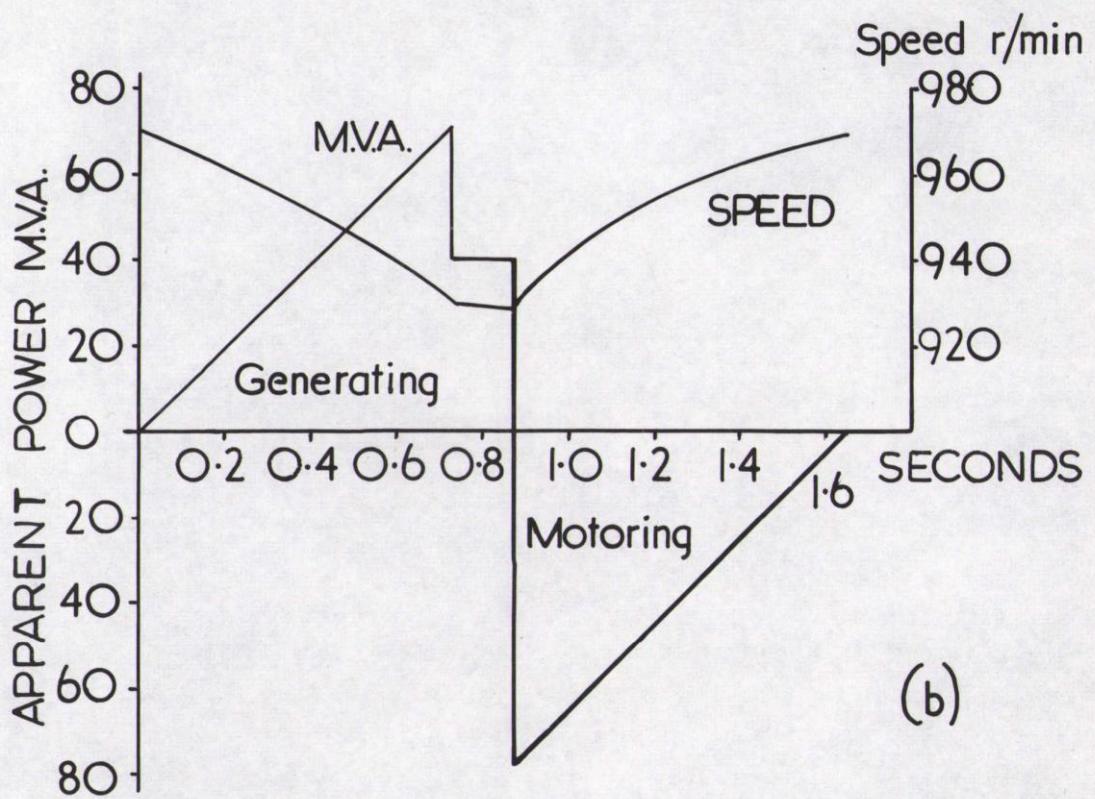
FIG. 4 SIMPLIFIED CHARACTERISTICS SHOWING ALTERNATOR LOADING DURING A TYPICAL PULSE

Figs. 4a and 4b show the machine duty during a pulse.

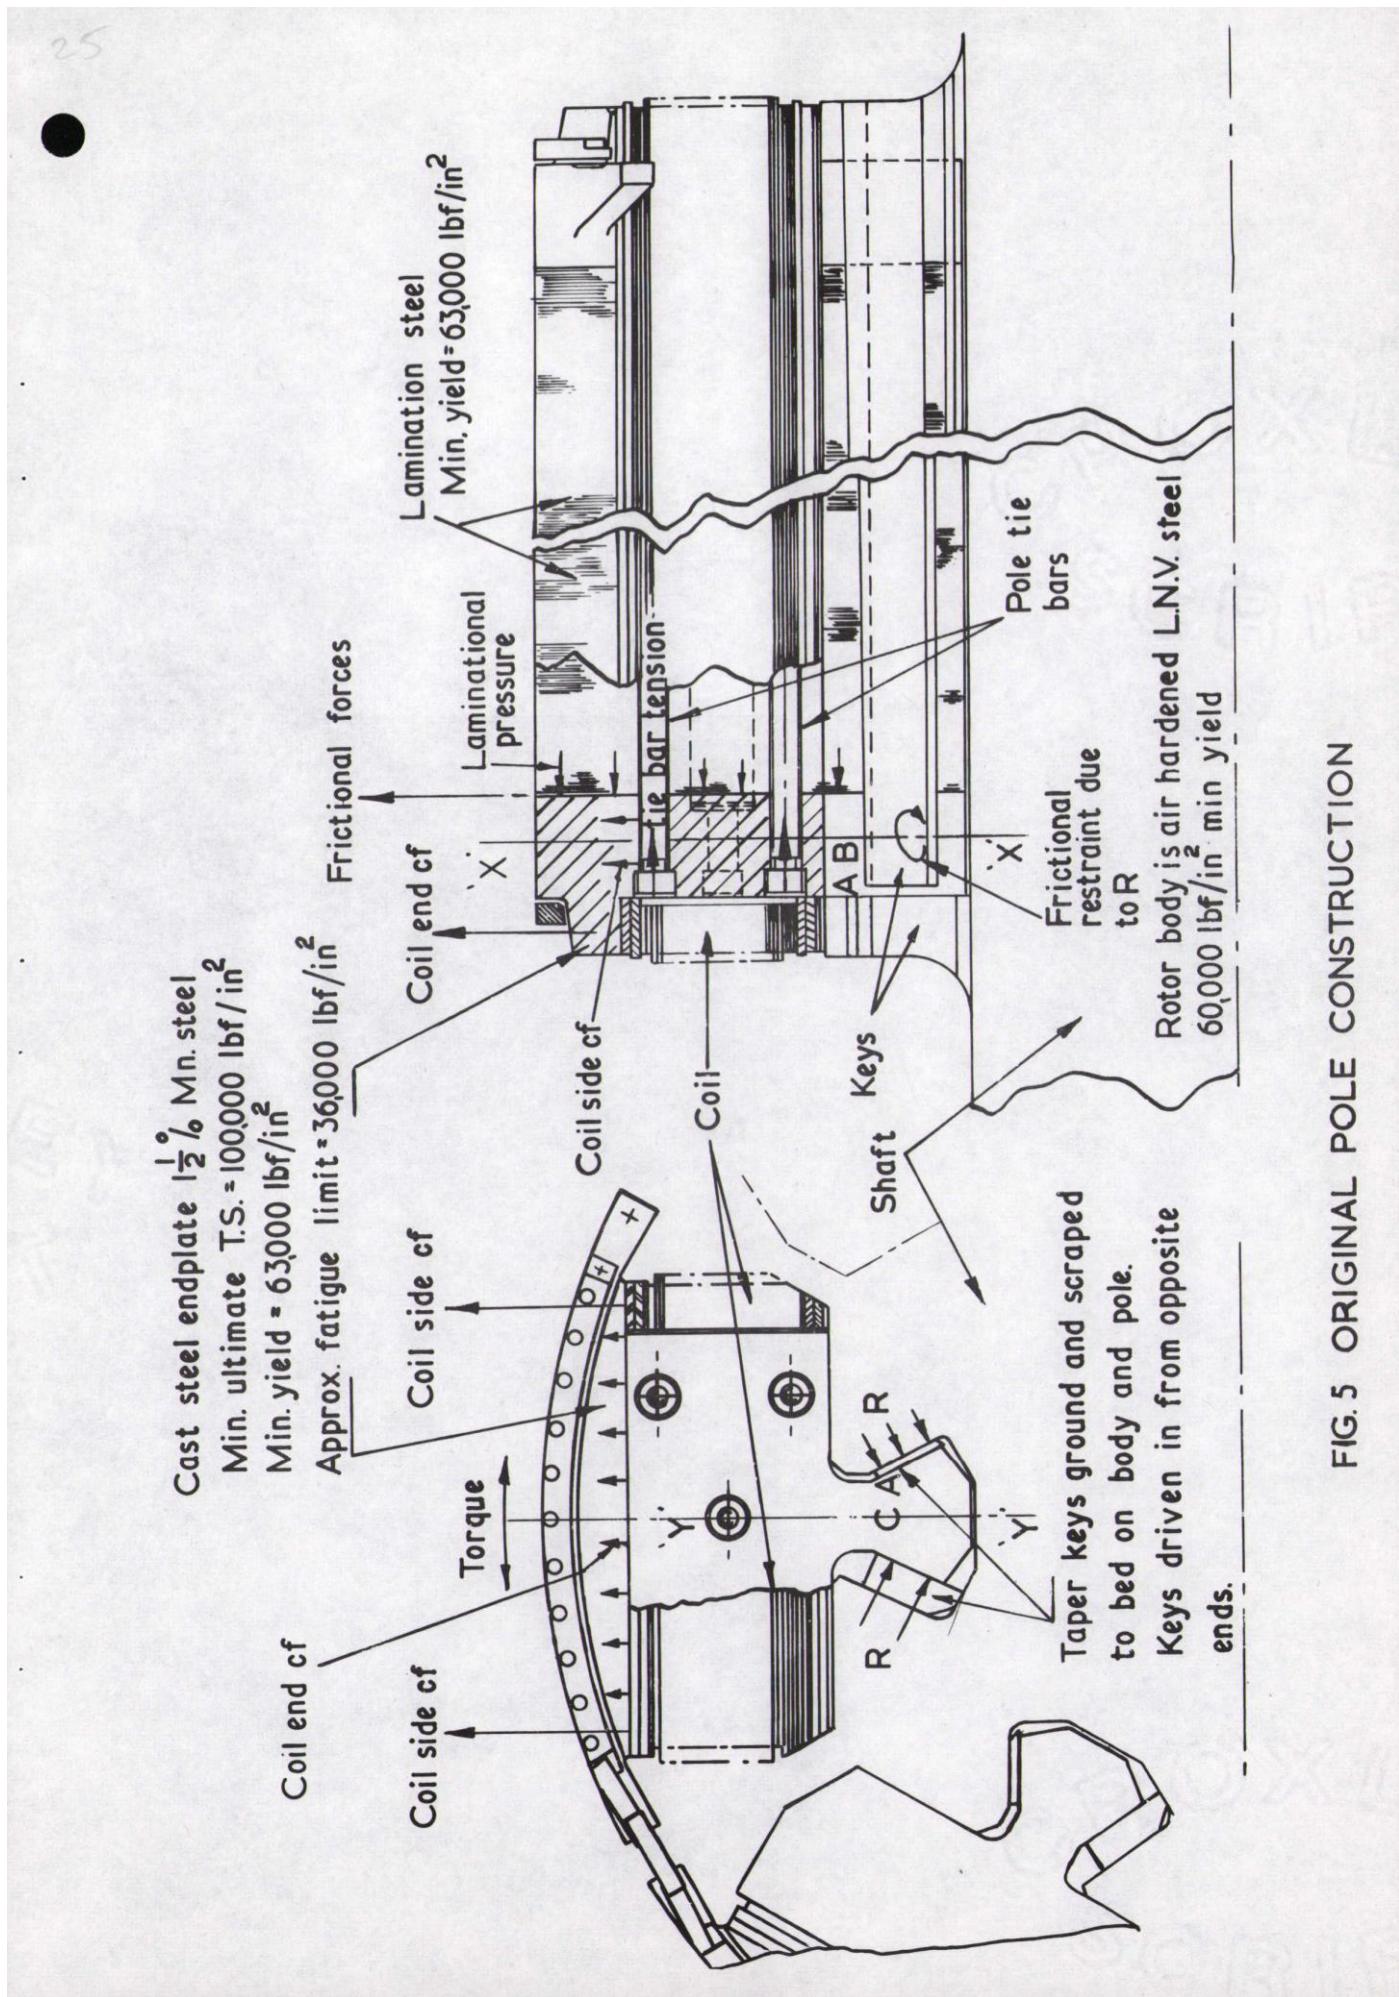
FIG. 5 ORIGINAL POLE CONSTRUCTION

The pole construction as originally designed is shown in Fig.5

The centrifugal loadings on the end plate arise from its own mass, and that of the part of the rotor coil which it supports. From Fig.5 it will be seen that the end turns are supported on a projecting lip on the plate. At the original design stage it was considered that this eccentric load was resisted by the laminations and that the end plate was able to take up the appropriate attitude. However, if the dovetail is restrained and the support offered by the laminations small (i.e. the pole is loosely consolidated) then considerable bending moments can be produced about the axis X-X (See Table I and Fig.5). Close examination and measurements on the poles showed that such a mode of behaviour was indeed possible even with normal consolidation.

pressure and a resulting rotational frequency bending about the X X axis (Fig.5). This stress is very difficult to estimate with any certainty. Nevertheless calculated and measured values showed reasonably close agreement. This stress variation is a feature of all horizontal machines of keyed laminated pole construction.

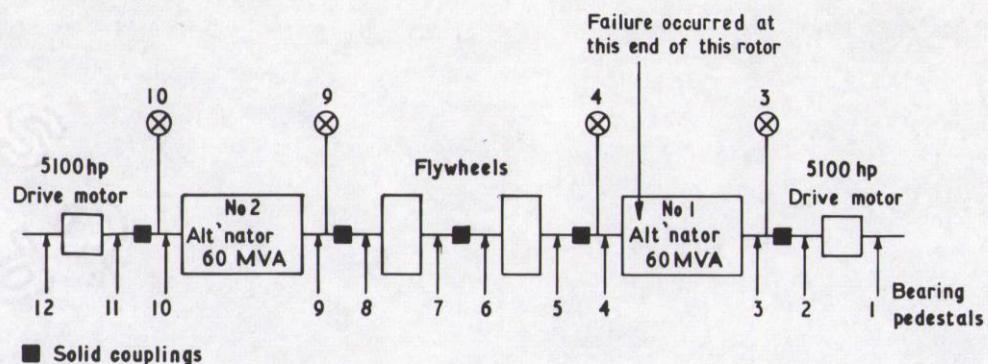
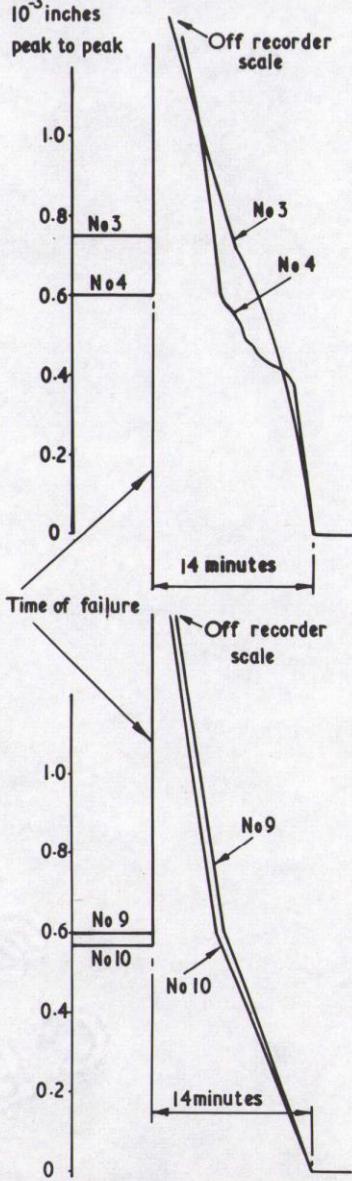
FIG.6 SHAFT ECCENTRICITY & VIBRATION

The rotating plant has vibration pick ups mounted on every bearing pedestal and shaft eccentricity pick ups are mounted adjacent to the alternator bearings. Fig.6 shows these locations and the alternator eccentricity and vibration recordings immediately before and after the fault occurred. It can be seen that all appeared to be very normal even seconds before the incident.

Alternator Bearing Pedestal Vibration Recordings At Time Of Failure

Alternator Shaft Eccentricity Recordings At Time Of Failure

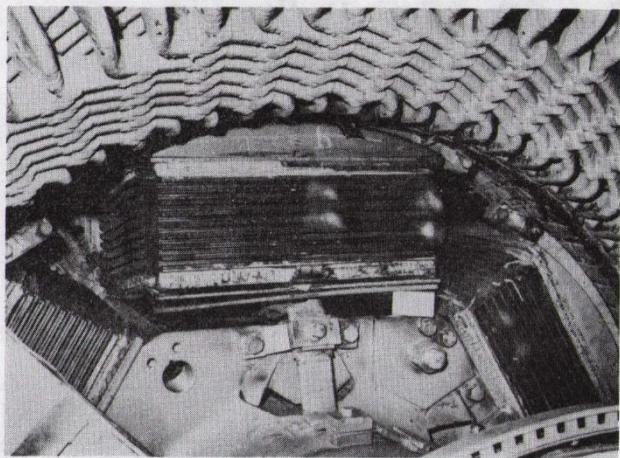
FIG. 7 DAMAGED POLE AND STATOR

The fault was caused by the failure of a rotor pole end plate across the neck region, (Fig.7), and the broken piece showed clearly the characteristics of fatigue failure (Fig.8). The stator was badly damaged and had to be rewound.

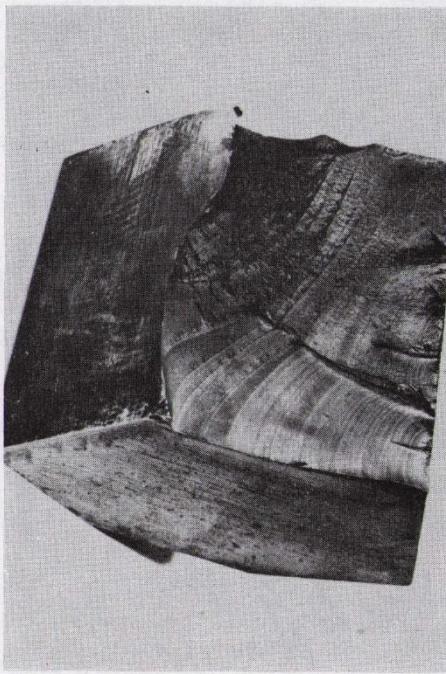
FIG. 8 LOWER HALF OF FRACTURED DOVETAIL

Examination of the fractured dovetail showed it to be a classical example of a fatigue failure with multiple starts, (Fig.8). The failure surface indicated several million cycles. The cracks had started on the side of the dovetail near the key corner, and had then propagated across about 75% of the section area before final tensile fracture occurred. Four other end plates of the failed rotor were found to have cracks in an earlier stage of development. One of these end plates clearly showed the multiple starts to the cracking (Fig.10). It was interesting to note that all failures, except one, appeared to be at the flywheel end, where the large shaft torque changes occur. Examination of the various cracks suggested that they all started in the area A, B, C of Fig.5. There was little evidence of a preferred side for the crack to start. This suggested that tensile and transverse bending stresses could be significant.

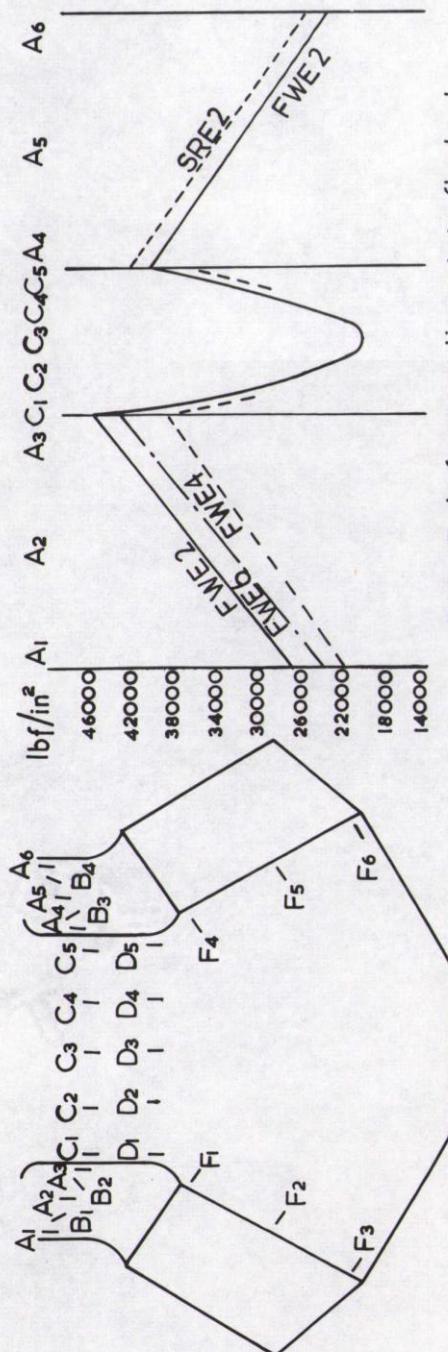
FIG 9 STRAIN GAUGE LOCATIONS & MEASUREMENTS

Initially considerable difficulty was experienced due to slipring noise but nevertheless it was found that the stress distribution across the neck with the set at no load speed was as shown in Fig.9. It was also noticed that superimposed on the D.C. stress due to CF force was an alternating gravitational component of stress at rotational frequency having an approximate value of  $\pm 1450 \text{ lbf/in}^2$  also shown on Fig.9.

(a) Strain gauge layout

Part of high speed trace when machine is at full speed showing alternating component of stress of  $\pm 1450 \text{ lbf/in}^2$  at rotational frequency  
(c) Gravitational component traces

The gravitational component of stress when the machine is running at a constant no load speed as shown in Fig.9 was clearly observed however. This suggests that any excess stresses at rapid torque change periods (beginning and end of flat top) should have been apparent, as should any stresses due to mechanical resonance effects. No such excess stress levels were observed.

Fig.18 shows typical results obtained and once again no excess cyclic stresses were observed. The form of stress make-up shown in Fig.12 is seen to be generally confirmed. Again the gravitational component of stress as shown in Fig.9 can be seen.

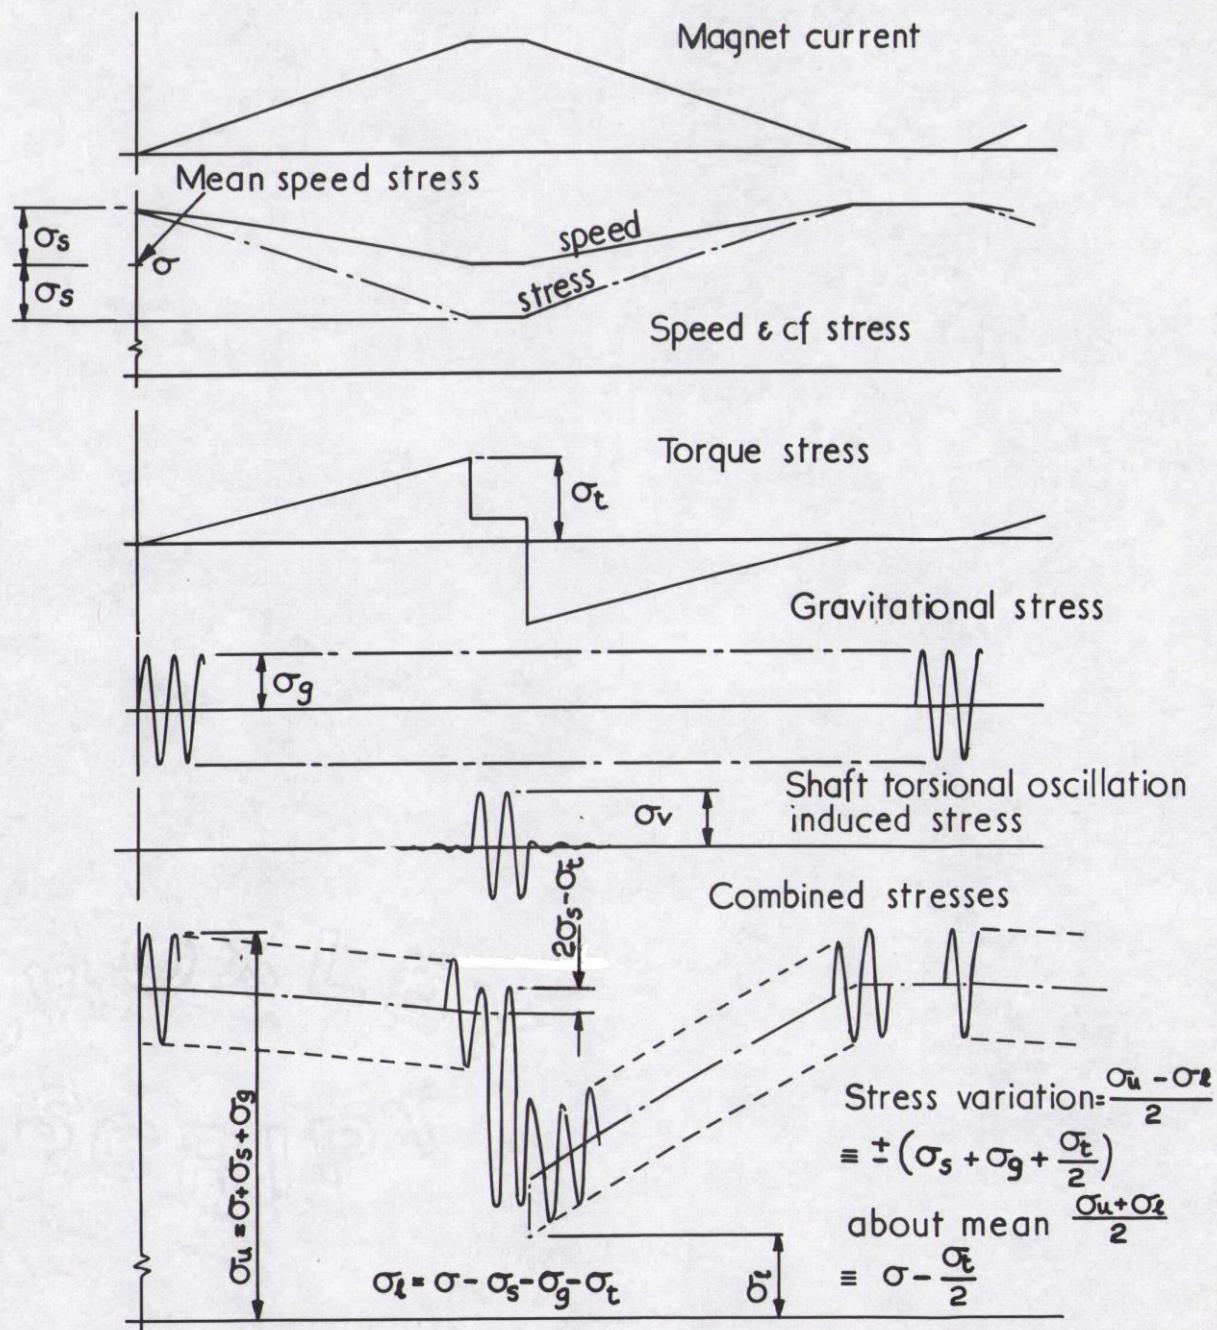
FIG.12 STRESS VARIATIONS (SIMPLIFIED) DURING PULSE

Reference to Table I shows that without stress concentration it was estimated that the mean direct tensile stress across the neck was in the range 31-39,000 lbf/in<sup>2</sup> upon which was superimposed a variable component of 3,400-4,200 lbf/in<sup>2</sup>. The make up of these stresses is shown in Fig.12.

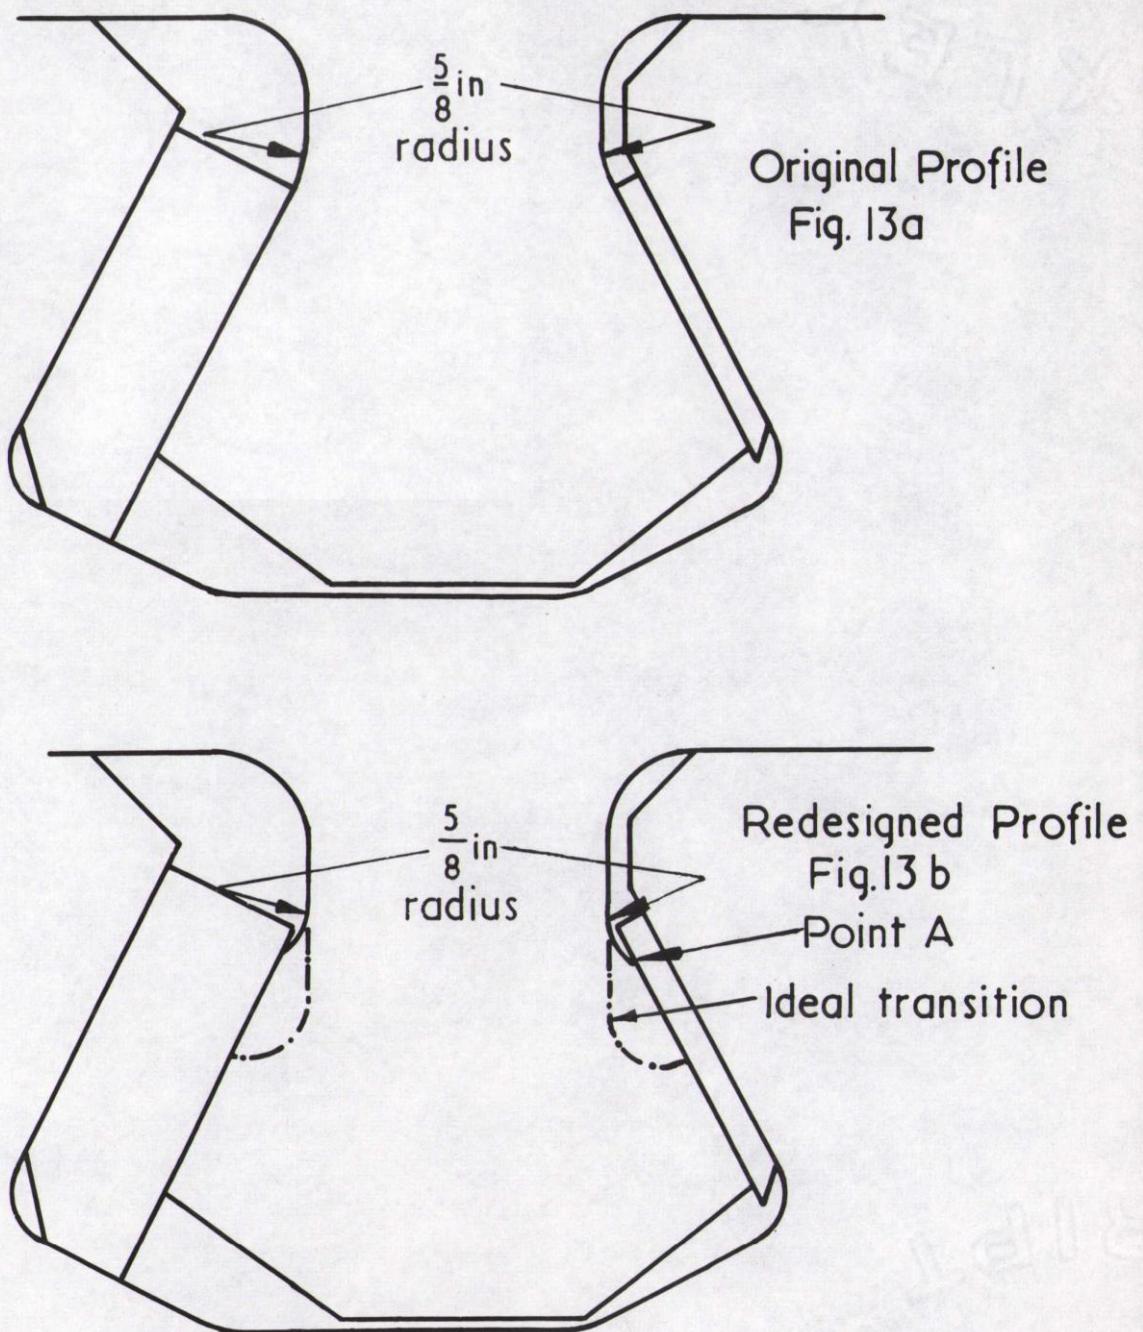
FIG.13 POLE DOVETAIL PROFILES

4.3 If either fretting or stress concentration was significant in the failure then steps were necessary to modify the dovetail end plate and lamination geometry. The change is shown in Figs. 13a and 13b. If under the high loads the assembly behaved as solid material, there was a smooth transition between neck and key somewhat reducing any stress concentrations in the tensile fibres. If fretting was a contributing factor to failure then it would occur at point A, but since this was now considered to be in a region of reduced tensile stress the possibility of crack formation and propagation was reduced. Further down the key-pole interface the conditions of fretting and tensile stress very rapidly improve and failure here was extremely unlikely. It was not possible to provide an ideal transition radius normal to the bedding face, due to strength restrictions on the remaining dovetail section (Fig.13b). Additionally the key was extended axially past the pole.

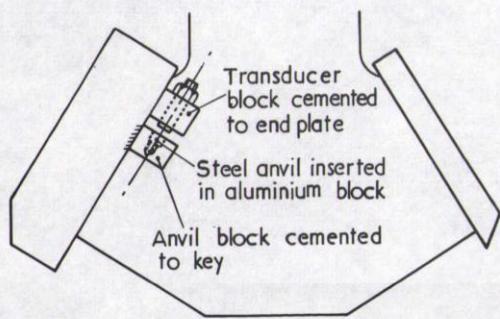
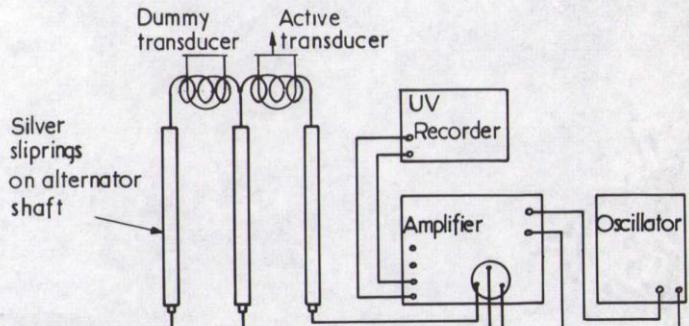
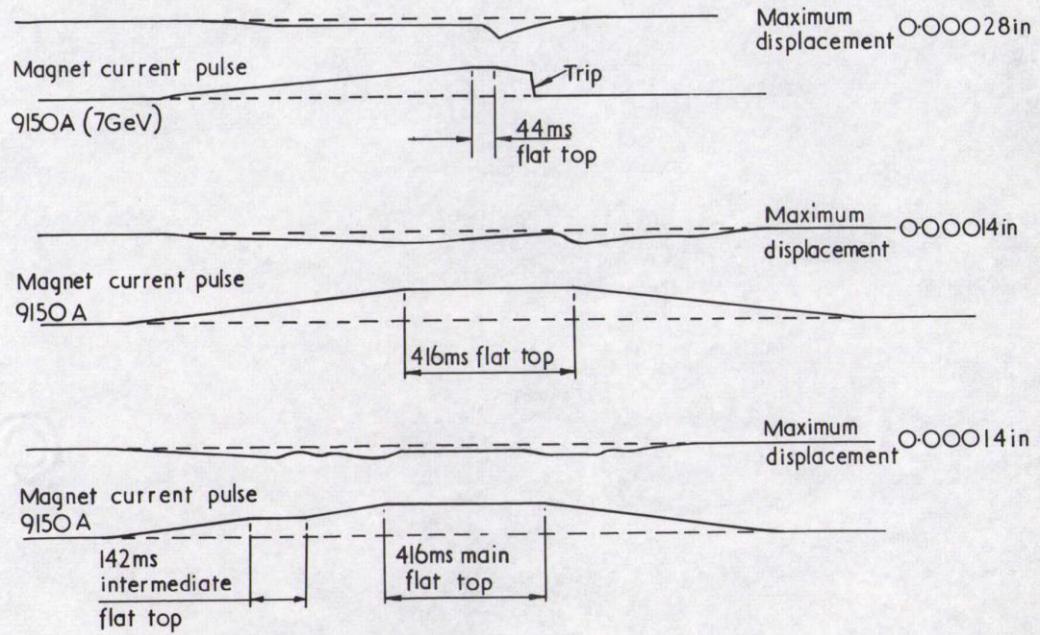
FIG. 19 MEASUREMENT OF KEY-ENDPLATE MOVEMENT

The transducer used was of the double variety so that one transducer could be used as a temperature compensating dummy while the other was used for the displacement measurement<sup>5</sup>. The block diagram of the circuit used is shown in Fig.19b. The transducers formed two arms of a bridge; the other two arms were inside the amplifier and were adjusted to balance the bridge. The bridge was fed with a 30 volts peak to peak signal at 50 K c/s and under these conditions a sensitivity of 20 mV per 0.001" of movement was obtained. The amplifier increased this sensitivity to 200 mV per 0.001" of movement.

When the machine was run up to speed a displacement between key and end plate of 0.004" was observed. As the machine was shut down the key and end plate resumed their zero speed position.

Fig.19c shows various key movements recorded under a variety of pulsing conditions.

It is interesting to note that these preliminary results suggested that with longer flat top settings the total displacement was reduced. It is frequently held that the most serious frettage attacks which tend to lead to cracking occur when the relative displacements of the two surfaces in question are in the region 0.0002" - 0.002". With larger amplitudes of movement the surfaces often wear rather than crack. Relative movements of key and end plate assembly on the present machines appear to be in this critical range under pulsing conditions.
